International Temperature Control, Inc.

Newsletter

TROUBLESHOOTING INJECTION MOLDING PROBLEMS

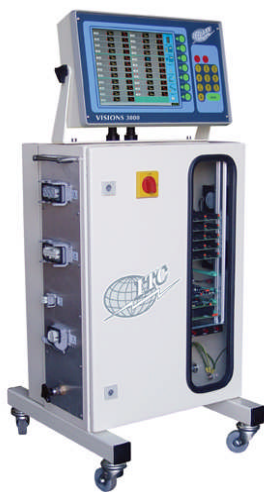
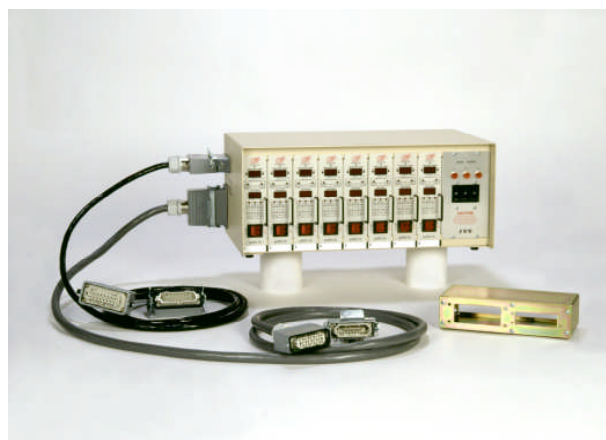
How ITC Hot Runner Controls can Assist in Diagnosing a Mold Problem

System Type	Areas Within the Mold's Hot Runner System Which Can Be Diagnosed
S20-D3C Control Module	Detects Open Thermocouple, Reversed Thermocouple, Shorted Thermocouple, Open Heater, Reads Actual Amperage/Current Drawn of the Heater, High or Low Zone Temperatures
UATC-20 Control Module	Detects Open Thermocouple, Reversed Thermocouple, Shorted Thermocouple, Open Heater, High or Low Zone Temperatures, Shorts to Ground, Reads Actual Amperage/ Current Draw of the Heater, Senses & Alarms when a Heater exceeds its established Current / Amperage parameter
VISIONS 3000 Control System	Detects Thermocouple Open, Thermocouple Reversed, Thermocouple Shorted, Open Heater, High/Low Zone Temperatures, Detects a Failure in Water Cooling System, Senses if a Heater Draws Excessive Current, 3 Dimensional Display of the Operating Temperatures of Every Mold Zone on a Single Screen, 3 Dimensional Display of the Current Draw of Every Mold Zone Single Screen, A Full Suite of Diagnostic Functions which can be run before putting the tool in the machine = includes Swapped Heater or Thermocouple with affected zones, Heater Power Monitoring to detect leakage, Heater Resistance Monitoring to predict failure, Measured Resistance of each heater for failure analysis, Additionally a complete report of the molds characteristics can be printed for future
